U. S. NAVY SUPPLY OFFICE-SCHOOL
NAVAL SUPPLY DEPOT, BAYONNE, NEW JERSEY

NAVY REPORT SERIAL NO. NT-003-010

PROJECT REPORT NO. 2.4190

DEVELOPMENT OF SHORE PARTY EQUIPMENT
(STEEL WIRE PALLETS)

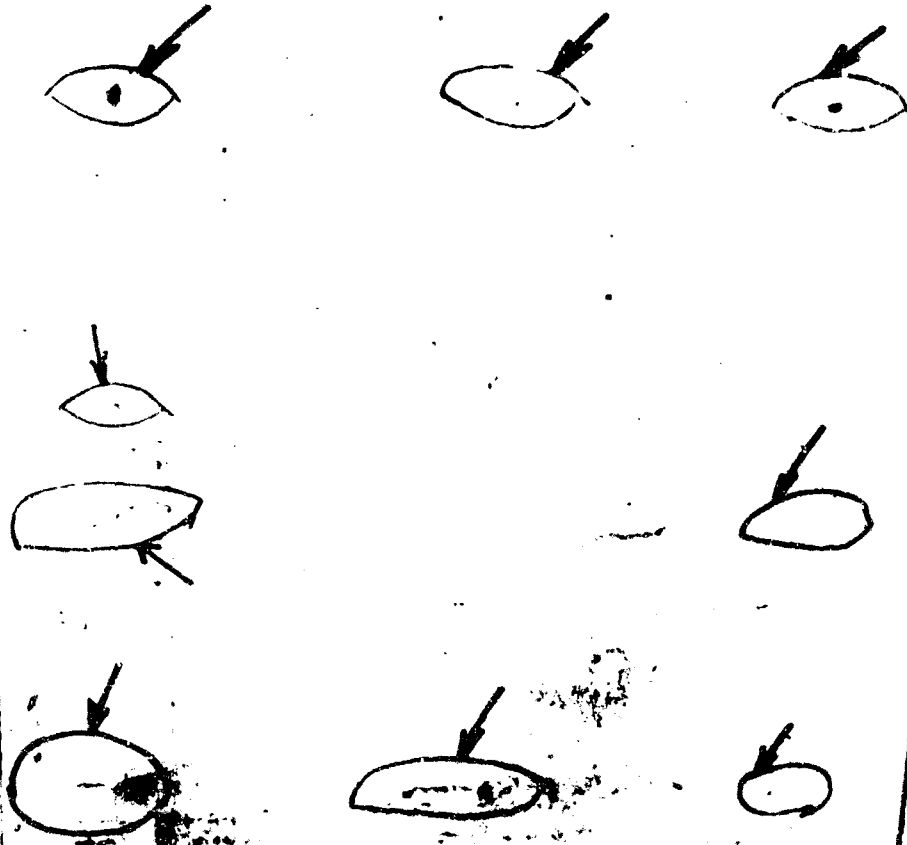
DEFORMATION OF FOREBOARD LACE RESULTING FROM HORIZONTAL AND VERTICAL LOADS.

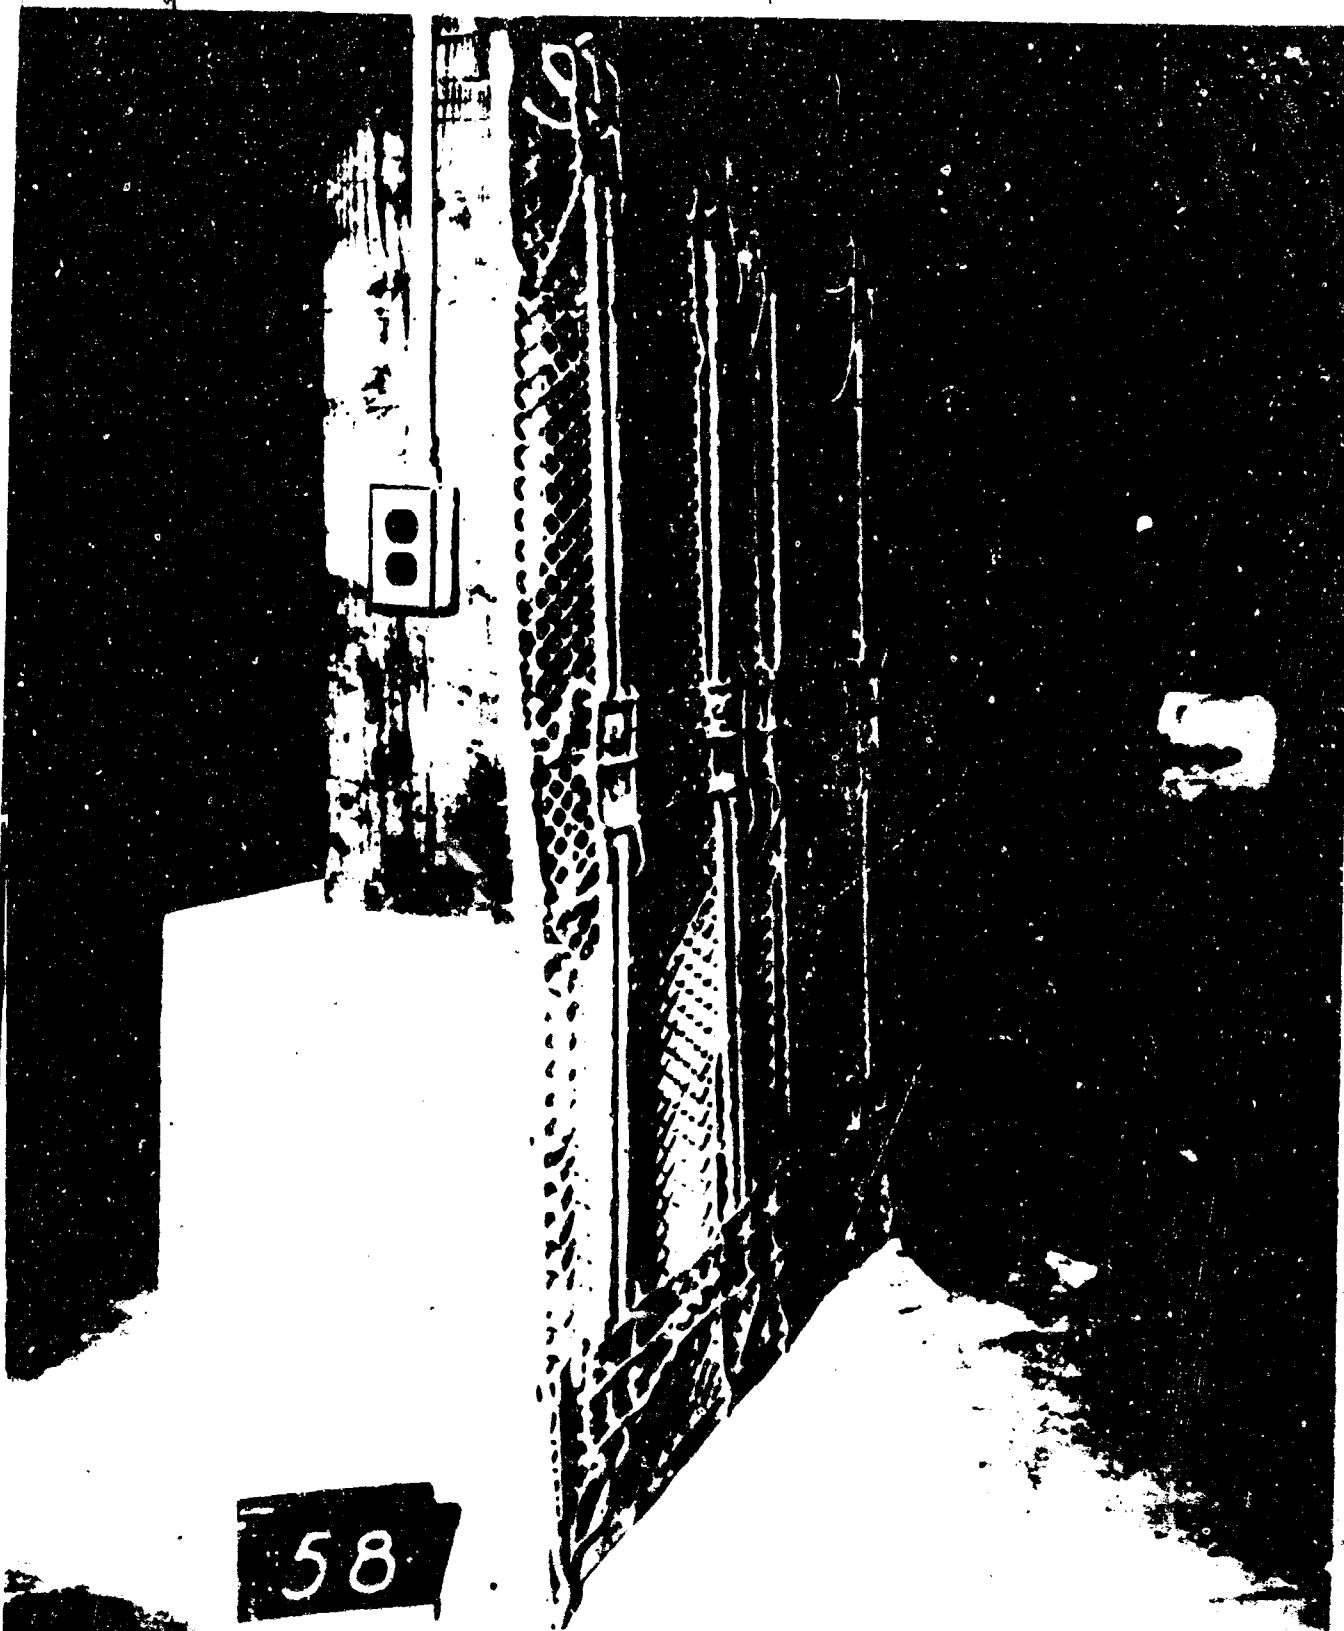
ILLUSTRATION OF RESULT TO
EXPANDED METAL DECK PALLET
"D" IN FREIGHT LIFTING
TEST. PALLET WAS DAMAGED
SLIGHTLY PRIOR TO TEST.
